Manhole Inspection Summary

Manhole # S29MM1004MH

Insp Date: **4/24/07 12:50 PM**

Location Address: **200 COLD SPRING LN**

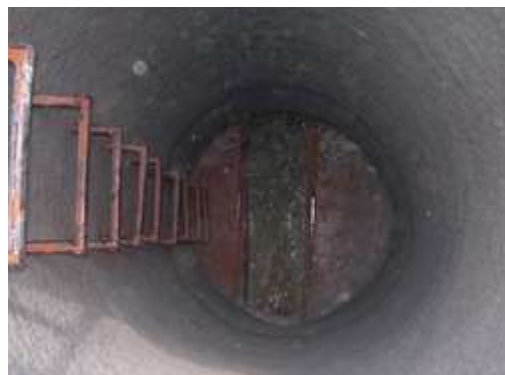
Top View

Bench debrus.

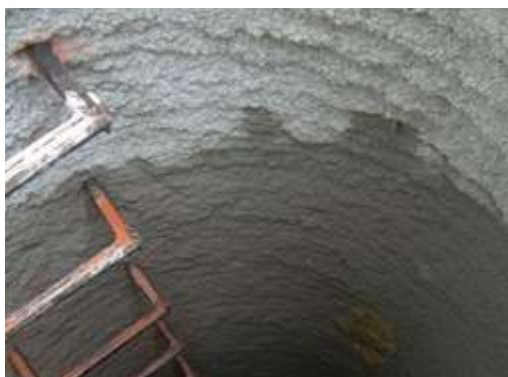
Defect

Barrel infiltration.

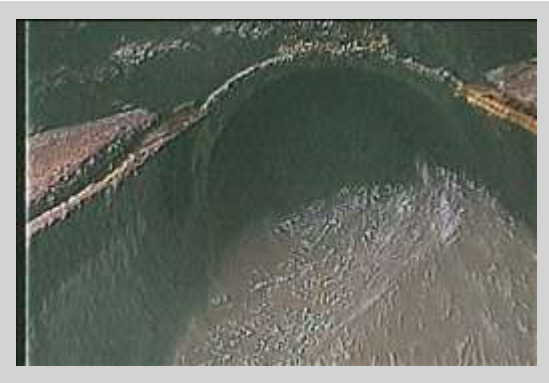
24 in. Circular Gravity Sewer Pipe Out @ 12 O'Clock

Pipe Material: **Unknown** ☒ Pipe Lined

Invert Depth: **16.85** (ft.) Flow Characteristics: **Fast**

Deposits: ☒ None ☐ Mud ☐ Sludge ☐ Debris ☐ Grease

Infiltration: **None** Pipe Seal Cond: **Unknown**

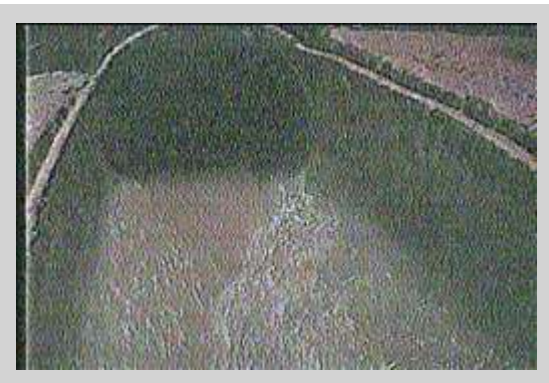
21 in. Circular Gravity Sewer Pipe In @ 6 O'Clock

Pipe Material: **Unknown** ☒ Pipe Lined

Invert Depth: **16.40** (ft.) Flow Characteristics: **Fast**

Deposits: ☒ None ☐ Mud ☐ Sludge ☐ Debris ☐ Grease

Infiltration: **None** Pipe Seal Cond: **Unknown**
